December 8, 2017

## **DISTRICT OF LILLOOET**

## **RE: PRE-RENOVATION HAZARDOUS MATERIALS ASSESSMENT LILLOOET COMMUNITY CENTER POOL CHANGE ROOM RENOVATION**

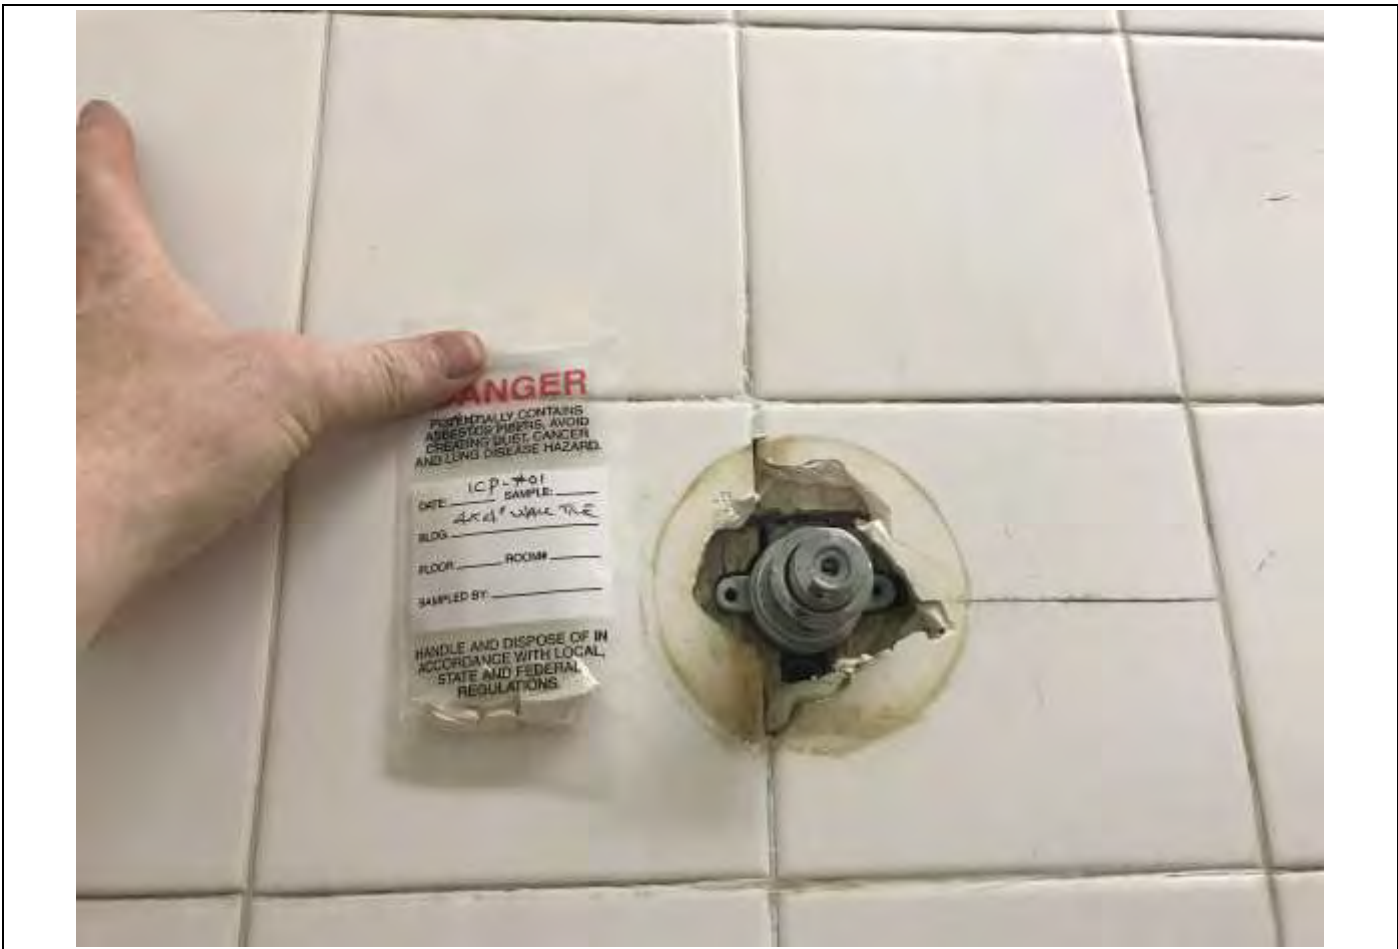
To identify if lead was present in paint applications of the shower room, swab samples were collected of painted materials with the use of Lead Check Kits. When activated, the swabs turn red in the presence of lead in concentrations greater than 600ppm, a level where uncontrolled removal could release airborne lead concentrations in excess of one half of the WorkSafeBC exposure limit. Swab results of white painted wooden surfaces in the change rooms revealed lead paint was present as the primer on all tested surfaces. To ensure lead was not present in the glaze used in ceramic tile, samples were collected of white wall and grey floor tiles to determine their lead content. Lead, in excess of 90mg/kg, a level that is harmful to pregnant women and children, was identified in the white wall tiles. Lead concentrations in the floor tile were less than the level of lead classification.

Picture No. 1: Sample 1 of white ceramic wall tile for lead analysis – results indicate lead is present in the glaze at a concentration of 292mg/kg

- 1) Create a fully enclosed, sealed and exterior vented HEPA filtered work area both within the change rooms and at access points to crawlspace area.
- 2) Utilizing Moderate Risk asbestos work procedures, remove lead painted and ceramic tile covered materials to extent of the scope of remedial work. Remove all surfacing and substrate materials back to building structure. Ceramic tile and unpainted wood materials may be disposed of as regular waste.

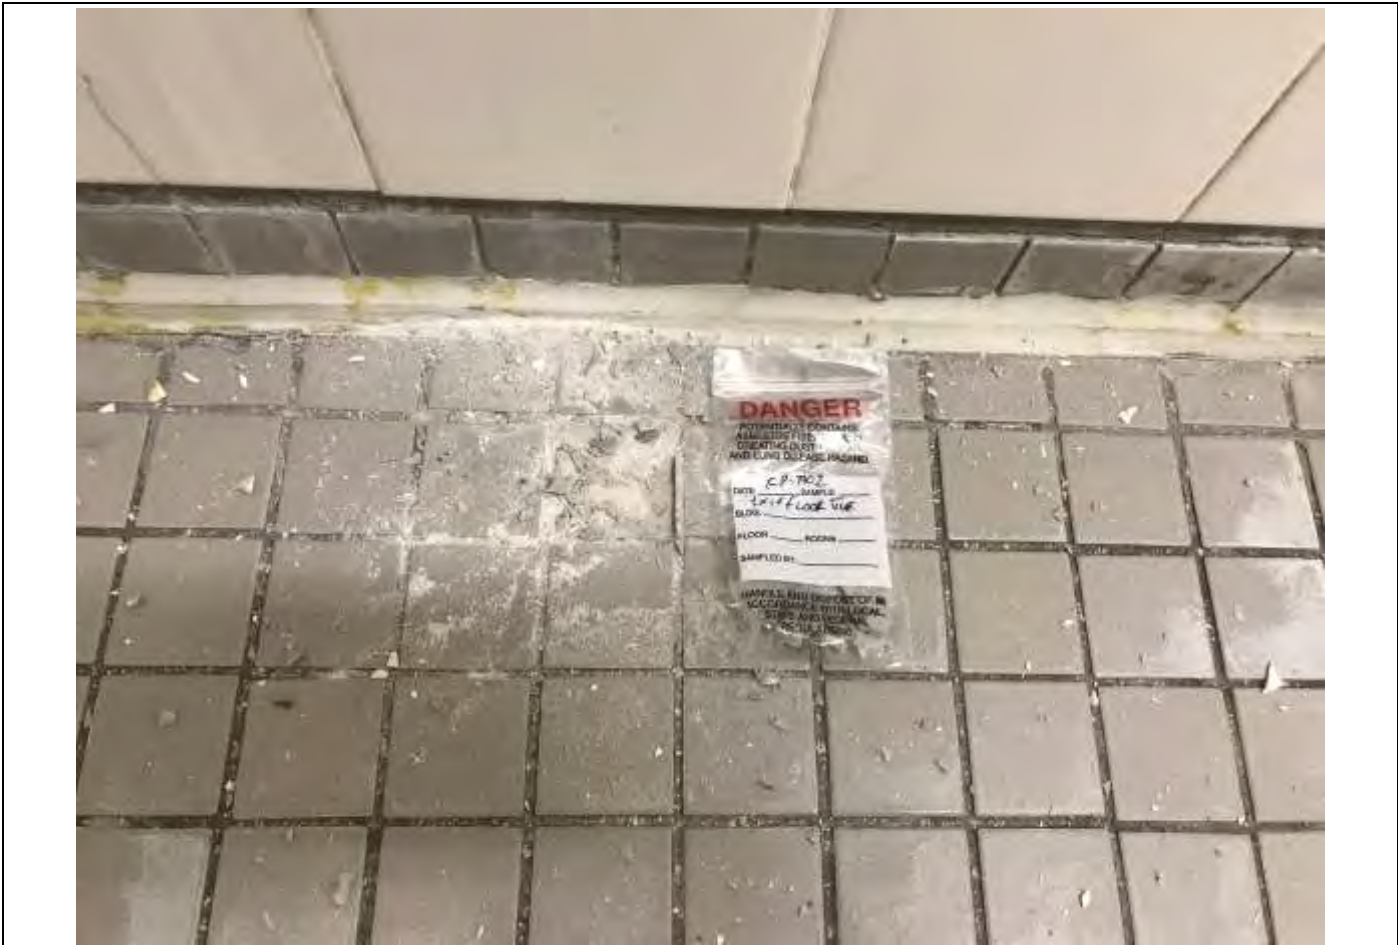
Picture No. 2: Sample 2 of grey ceramic floor tile for lead analysis – results indicate lead is present in the glaze at a concentration of 15.9mg/kg

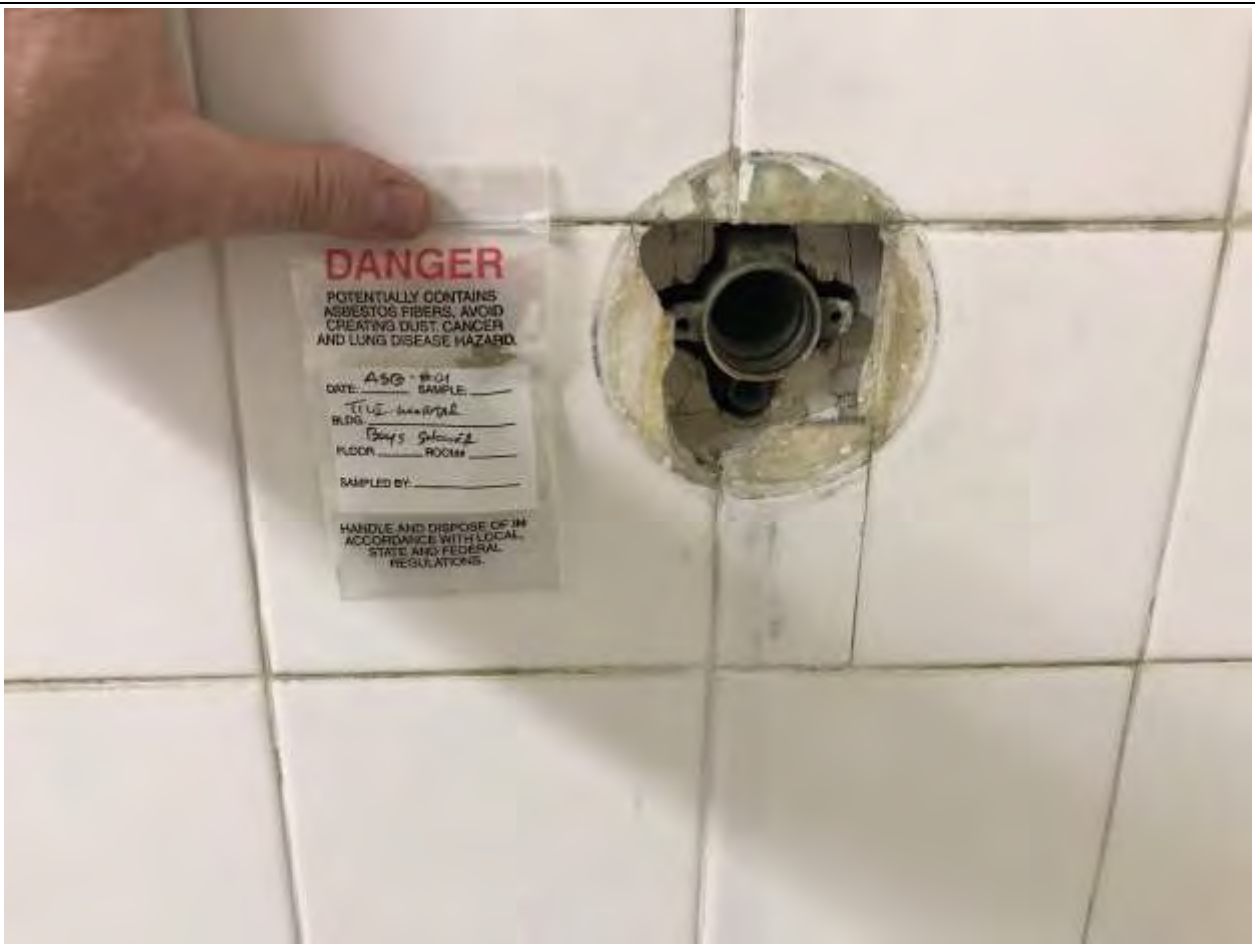
A review of the change room areas revealed all interior finishes were a mixture of wood and ceramic tile. Ceramic tiles were mortared on to plywood subflooring. A sample of mortar was collected and analysed to determine if asbestos was present in this material, with none being identified.

Picture No. 3: Sample 1 of mortar for asbestos content – results indicate no asbestos was present in the tested mortar

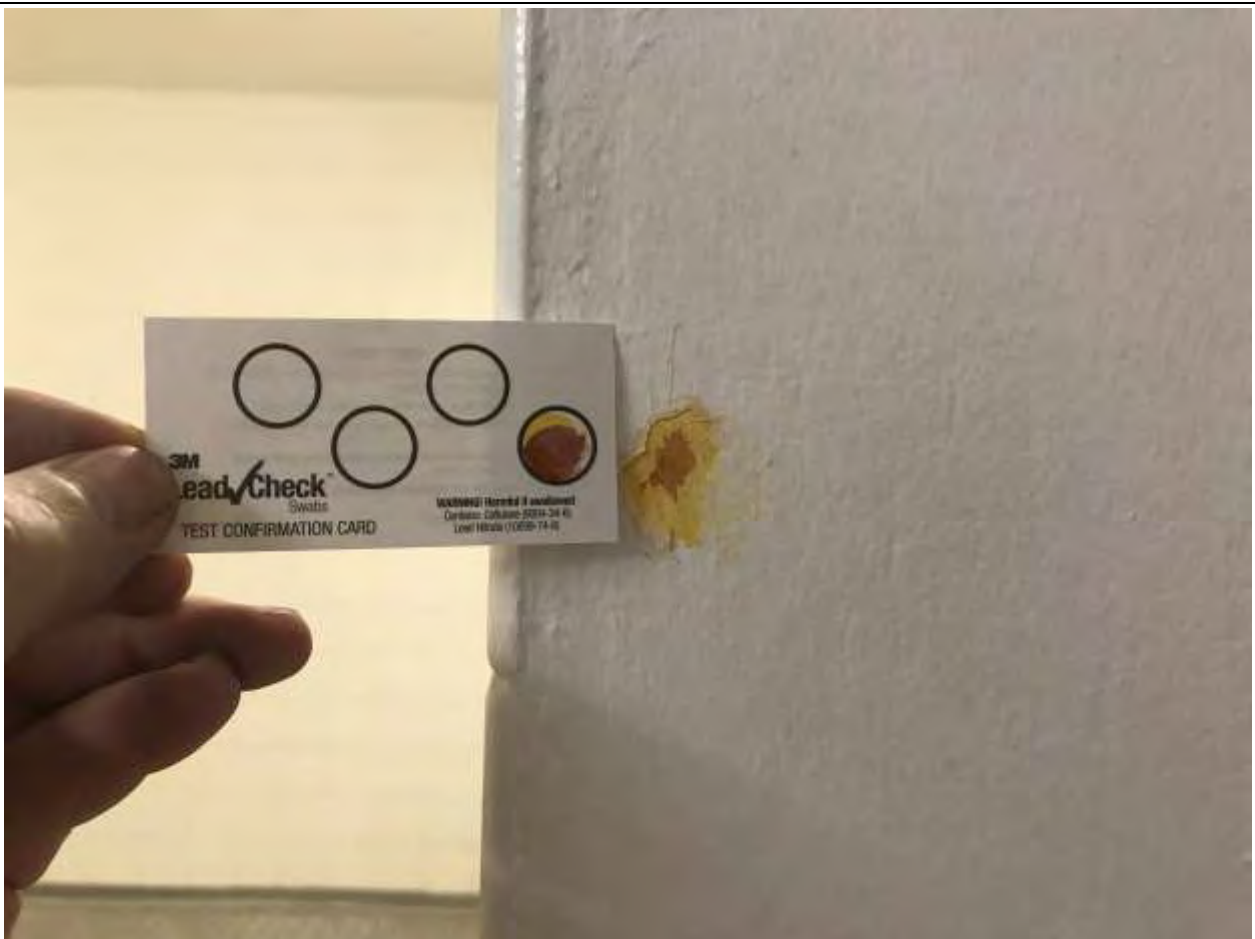
Picture No. 4: Swab analysis of painted wood – results indicate lead is present in the primer at a concentration greater than 600mg/kg

- 3) White painted wood materials must be TCLP tested to determine if the lead content renders the materials a special waste. A sample of collected paint and substrate material must be forwarded for analysis to determine if it has a leachable lead concentration in excess of the BC Ministry of Environment's Special Waste Classification of 5 mg/L. Materials found to be in exceedance of this criterion must be transported to the Swan Hills Treatment Centre in Alberta for treatment and disposal as hazardous waste.

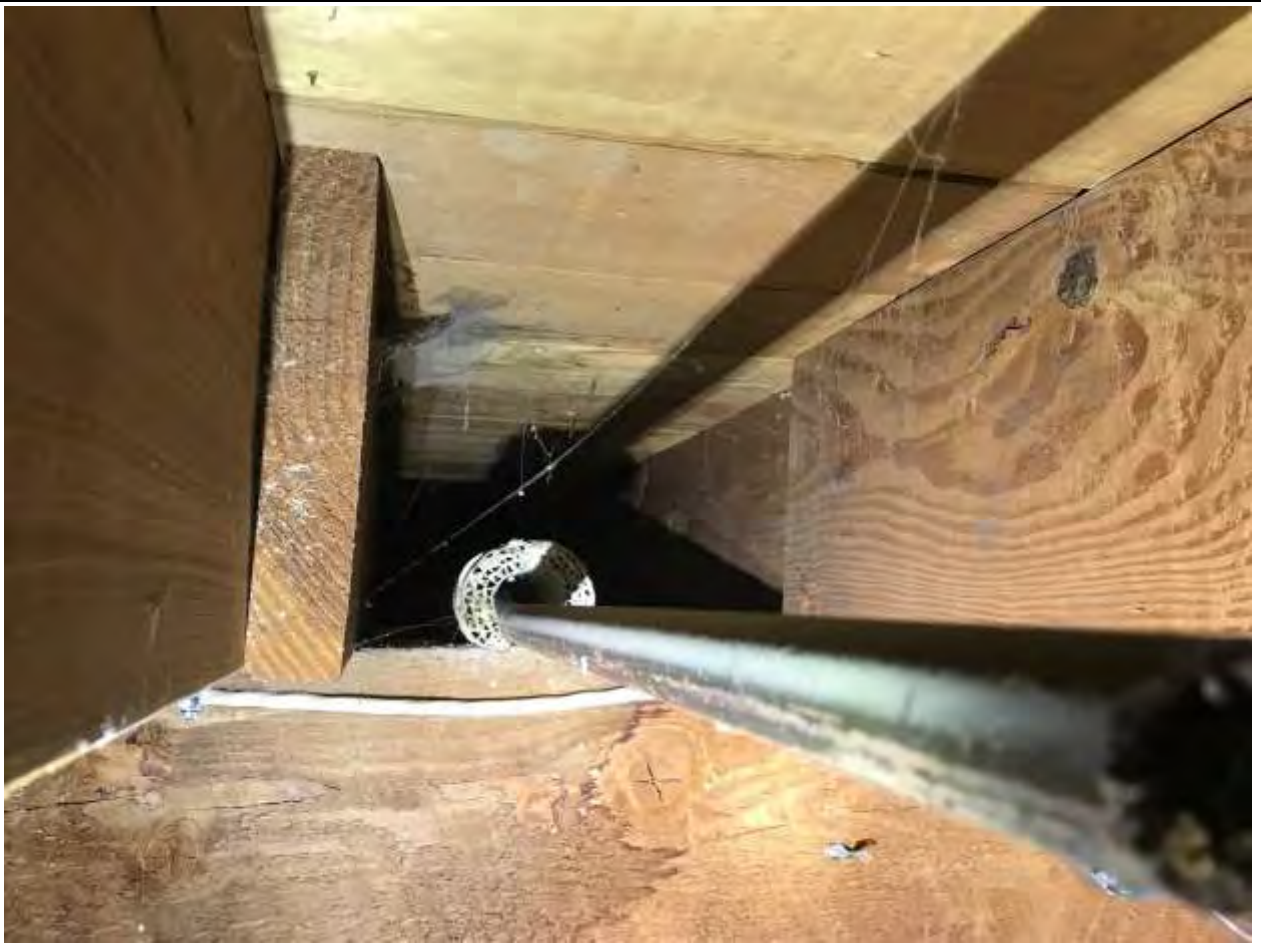
From our limited inspection of the crawlspace, poor condition asbestos insulation was identified on redundant heat piping in addition to asbestos debris identified in the dirt throughout the inspected crawlspace area.

- Asbestos is present within corrugated paper pipe insulation and insulating cement (pipe fittings) located on redundant piping and within the dirt under the change room area. High risk asbestos work procedures will be required to remove asbestos containing materials from this space

Picture No. 5: Corrugated asbestos paper on redundant piping in the crawlspace

- 4) Utilizing high risk asbestos work procedures, remove asbestos containing insulation from redundant piping and pipe fittings in the crawlspace area under from the change room back to the crawlspace access hatch. Further remove asbestos insulation debris from the dirt crawlspace through hand picking and rake scarification. Dispose of all created waste as asbestos containing materials.

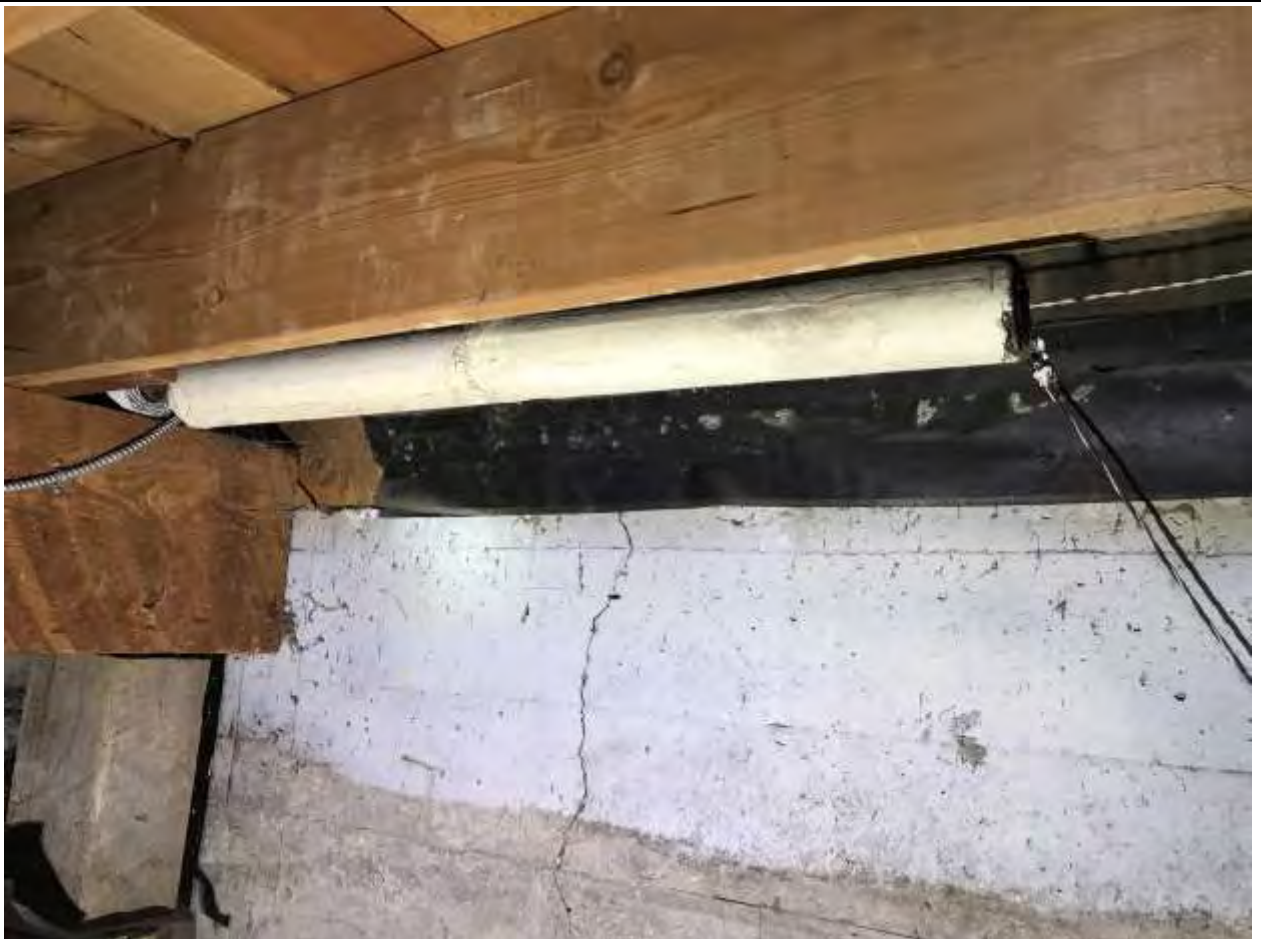
Picture No. 6: Section of redundant corrugated paper asbestos paper pipe insulation

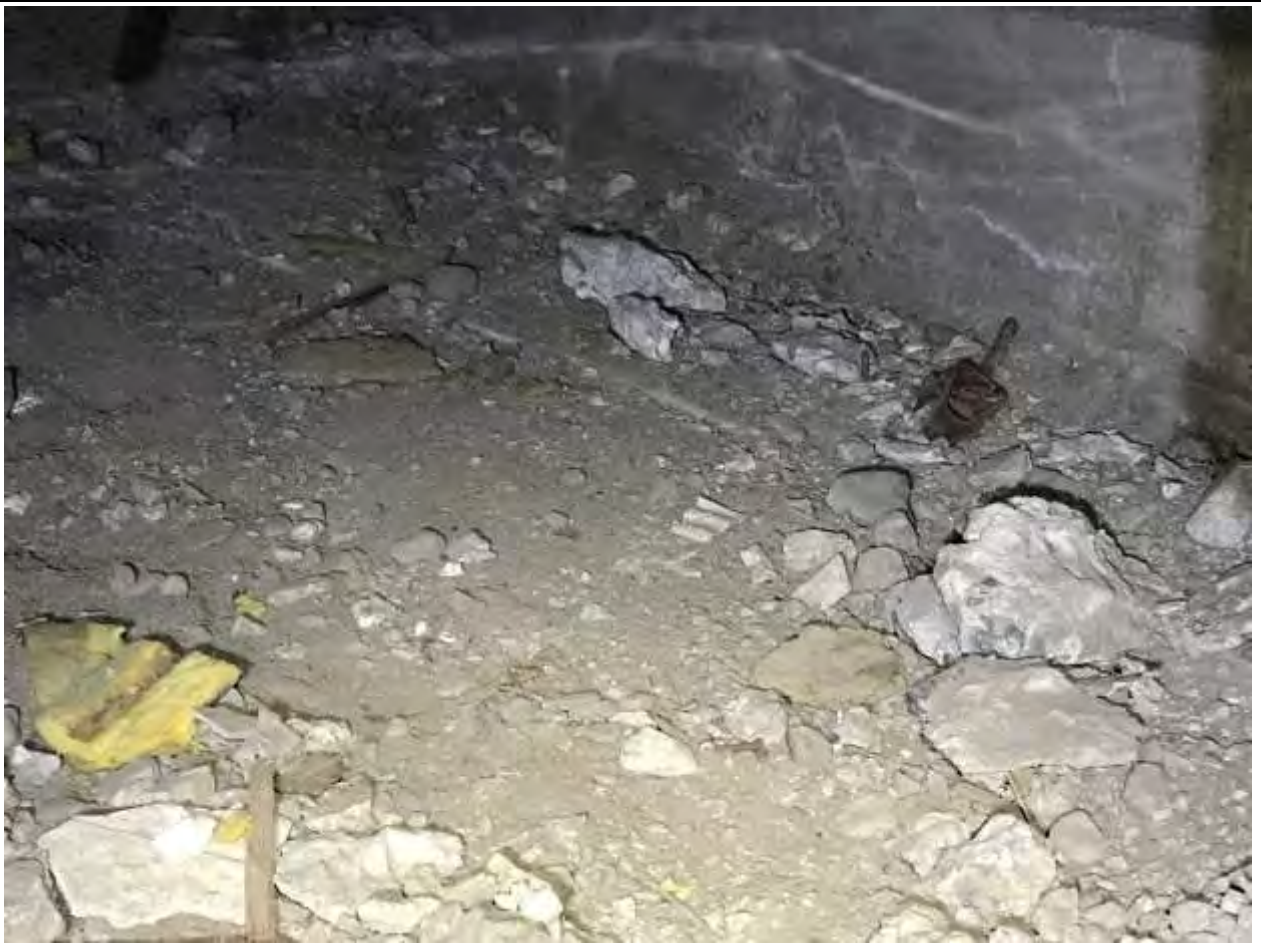
Picture No. 7: Asbestos paper pipe insulation debris within crawlspace dirt

- 6) Utilizing high risk asbestos work procedures, install a poly ground seal in the abated work area, sealed to all perimeter walls with butyl sealant to prevent air movement from the asbestos abated dirt to the general crawlspace area. As the removal of asbestos is visually performed, there still remains the potential for microscopic asbestos fibres to remain within the dirt. Unless protected with a concrete cap or some other suitable barrier, these fibres could be aerosolized from the dirt if persons enter the space without a suitable barrier.

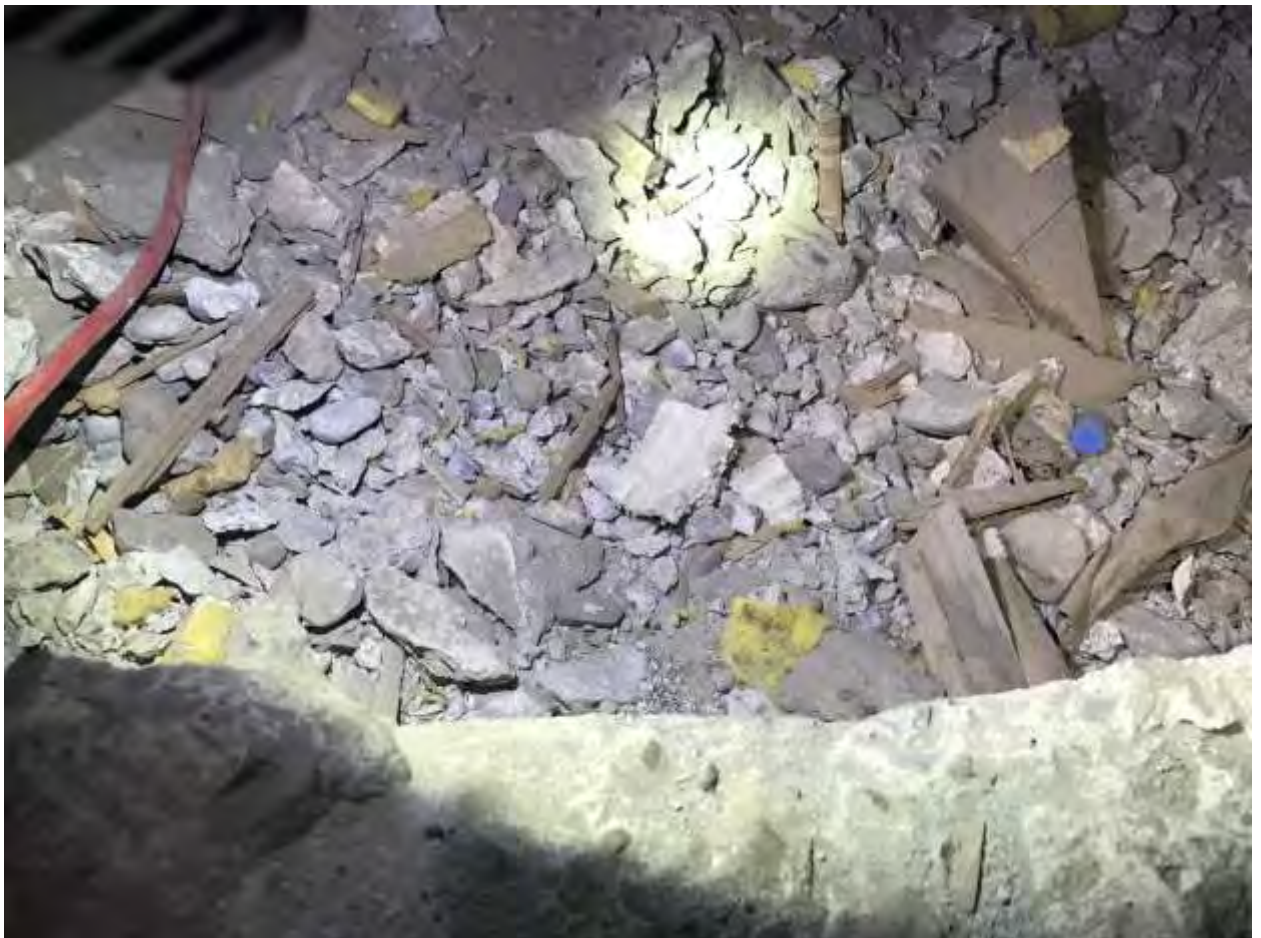
Picture No. 8: Asbestos paper pipe insulation debris within crawlspace dirt
